# Repair Methods and Applications to overcome Honeycomb, Cold Joint and Cracks in Concrete

Jonbi<sup>1</sup>,

**ABSTRACT :** In concrete work with structural complexity and large volume of concrete, damage to concrete often occurs such as honeycomb, cold joints and cracks. Damage is caused by internal and external factors and becomes a serious problem, it is not uncommon for demolition of the building to be carried out. Demolition is the last option, for that it is necessary to carry out several stages starting with root cause analysis whose aim is to find out what are the main factors causing damage to the concrete. Then forensic engineering is carried out through visual observation, UPV test, profometer, coredrill with the aim of knowing the quality of the existing concrete and the damage that occurs. The next stage of improvement is through the repair method in the form of grouting, material patching, and injection. Through proper and accurate application, the problem of damage can be solved. Based on the results of the work carried out in the field, it shows good results, so that it can solve the problem of honeycomb, cold joints and cracks that occur. These results prove tha

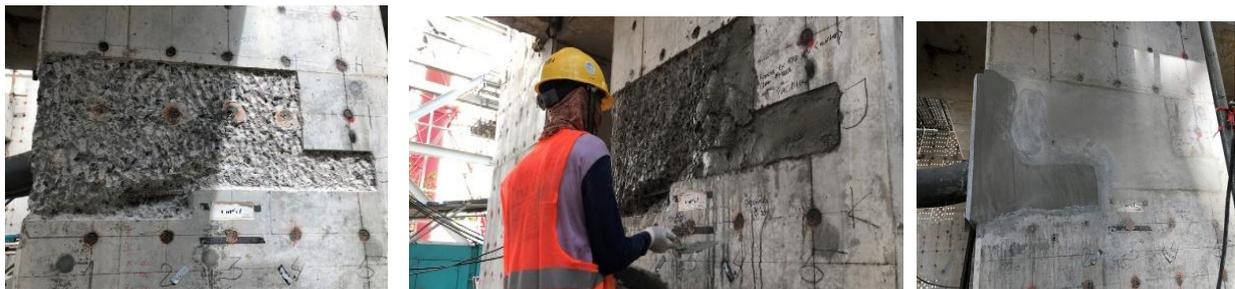
Figure 2. Honeycomb from 10 mm up to 10 mm upto less than 50 mm and concrete cover less than 40 mm

Type 1. Patching for Honeycomb from 10 mm up to less than 50 mm and concrete cover less than 40 mm(Fig.2)

Repair method and application : preparatory work: The surface that has been checked is sure to meet the requirements of a concrete cover  $\geq 50$  mm, Clean from dirt or dust. Primer with styrene Butadiene Rubber (SBR)Start the patch job by using a hand trowel Material Master Emaco S 5400 is a cementitious, polymer modified, one component, repair mortar containing reactive microsilica. Technical Properties Compressive Strength 28 days  $\geq 70$  MPa and adhesion to concrete  $\geq 2$  MPa

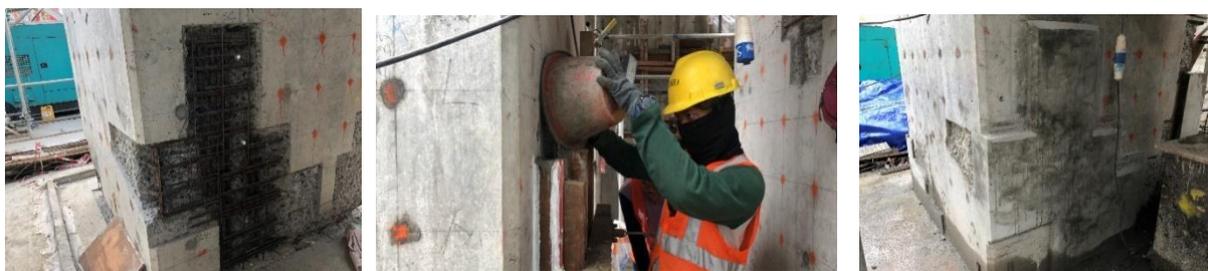
Figure 3. Honeycomb from 50 mm up to 100 mm

Type 2. Grouting Honeycomb from 50 mm up to 100 mm (Fig.3)

Repair method and application: chipping existing honeycomb, until it passes through reinforcement which is at least 10 mm. Chipping uses Hydraulics, to avoid damage to work. Chipping must be done by repair worker. Chipping is adjusted according to the existing damage zone. Install the shear connector every 250-400mm depending on the surface area to be grouted. Install formwork and attach strong and not leak. After everything is ready, Grouting can be done using a grout pump or pouring system by using for certain positions. Material shear connector is HILTI anchor HUS3-H Type

Material for Grouting: Master Flow 880 is non-shrink, iron aggregate precision grout with high early and ultimate strength. It is typically placed at a flow able consistency at thickness between 10 mm and 150 mm. Technical properties: Compressive strength  $> 90$  MPa and Flexural strength  $> 90$  MPa after 28 days.

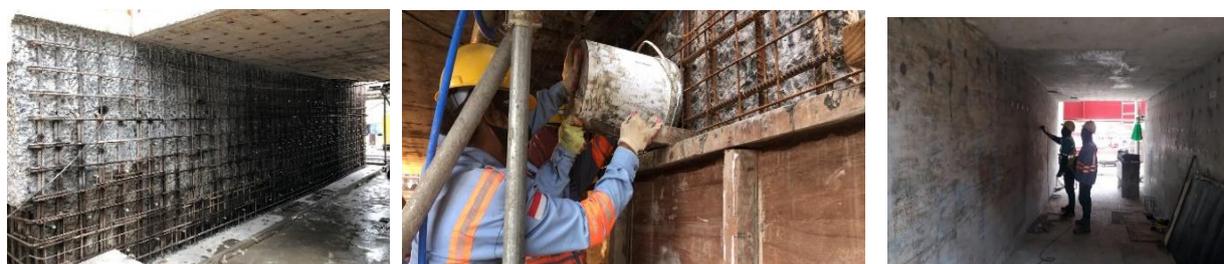
Figure 4. Large Honeycomb

Type 3. Grouting and injection Deepest Honeycomb (Fig.4)

Repair method and application : the injection packers inserted into pre-drilled holes shall be fixed at intervals along the length of each crack. Injection point drill depth is adjusted by internal honeycomb or at least 100 mm. The distance between each packer will depend upon the width and depth of the crack. Spacing shall be close enough to ensure that the resin will penetrate along the crack to the next point of injection. This will normally be between 100 mm and 200 mm. Before the grout work is carried out, the formwork installed must be strong, not leaky and use good materials to produce a flat concrete surface that is repaired. Master flow 880 has

good flow properties, so it can fill the deepest honeycomb. Meanwhile, to fill a small void, the injection pipe must be installed/ prepared, the pipe size is longer than the thick grouting. After everything is ready, installation work with Masterflow 880 can be done using a grout pump. then after 1 x 24 hours, injection work with epoxy to fill a small vacuum can be do Material for Grouting: Master Flow 880 is non-shrink, iron aggregate precision grout with high early and ultimate strength. It is typically placed at a flowable consistency at thickness between 10 mm and 150 mm. Technical properties: Compressive strength  $> 90$  MPa and Flexural strength  $> 90$  MPa after 28 days. Material for injection: Conbextra EP10TG epoxy is a two part, solvent-less, low viscosity, non-shrink epoxy resin system that forms a permanent bond and seal in cracks in concrete. Crack widths between 0.25 mm - 10 mm can be treated. This epoxy is designed to be injected into cracks using suitable resin injection equipment. The injection pressure should be at least  $0.4 \text{ N/mm}^2$  (4 Bar). Technical data : Compressive strength 7 days :  $83 \text{ N/mm}^2$  , flexural strength :  $63 \text{ N/mm}^2$

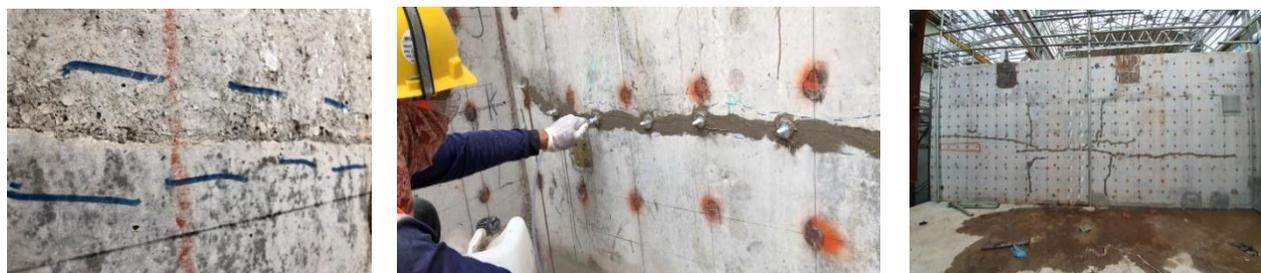
Figure 5. Repair work cold joint and cracks

Type 4. Injection with Epoxy to repair cold joint and cracks(Fig. 5)

Repair method and application : injection point nipel is affixed along the crack using epoxy sealing, which must be installed at intervals along the length of each crack. The distance between each packer will depend upon the width and depth of the crack. Spacing shall be close enough to ensure that the resin will penetrate along the crack to the next point of injection. This will normally be between 100 mm and 200mm.

Material for injection: Conbextra EP10TG epoxy is a two part, solvent-less, low viscosity, non-shrink epoxy resin system that forms a permanent bond and seal in cracks in concrete. Crack widths between 0.25 mm - 10 mm can be treated. This epoxy is designed to be injected into cracks using suitable resin injection equipment. The injection pressure should be at least  $0.4 \text{ N/mm}^2$  (4 Bar). Technical data : Compressive strength 7 days :  $83 \text{ N/mm}^2$  , flexural strength :  $63 \text{ N/mm}^2$

Epoxy injection work, if carried out with the correct repair method, has been proven to be able to overcome the problem of cold joints and cracks, this is in line with research conducted by several researchers [16].

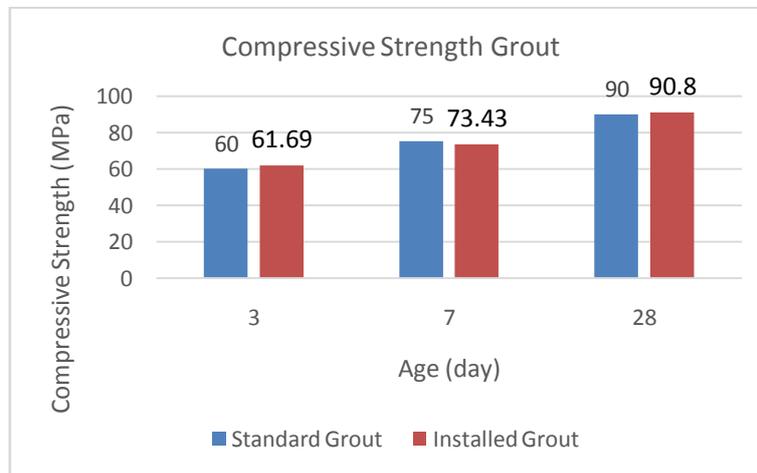
Figure 6. Compressive strength Grout

The results of the grouting material test that have been applied in the field and the grout standard from the producer show significant results as shown in Figure 6. The standard grout from the producer for 3 days > 60 MPa, 7 days > 75 MPa and 28 days > 90 MPa. Then the results of field tests for 3, 7, 28 days were 61.69 MPa, 73.43 MPa and 90.8 MPa. Thus, it can be ascertained that the grout material used is in accordance with the existing quality.

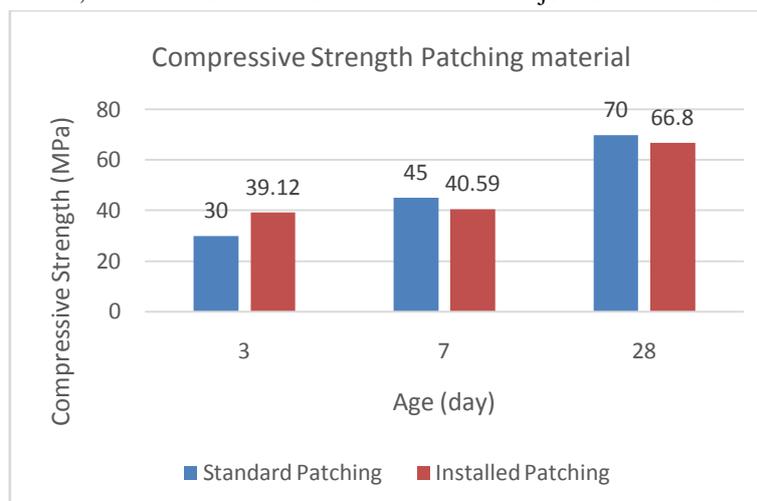
Figure 7. Compressive strength patching material

The results of the patching material test that have been applied in the field and the grout standard from the producer show significant results as shown in Figure 7. The standard patching material from the producer for 3 days > 30 MPa, 7 days > 45 MPa and 28 days > 70 MPa. Then the results of field tests for 3, 7, 28 days were 39.12 MPa, 40.59 MPa and 66.8 MPa. These results show the results of the compressive strength in the field reaching 95.4%, this is due to the weather conditions during application repair in the field, but these results are still acceptable
